**CLIFTON PARK WATER AUTHORITY
BOARD MEETING**

Blue Spruce Reservoir 2,000,000 Gallon Ground Storage Tank Inspection Report

Knolltop Tank 300,000 Gallon Hydropillar Inspection Report

Miller Road Tank 1,500,000 Gallon Hydropillar Inspection Report

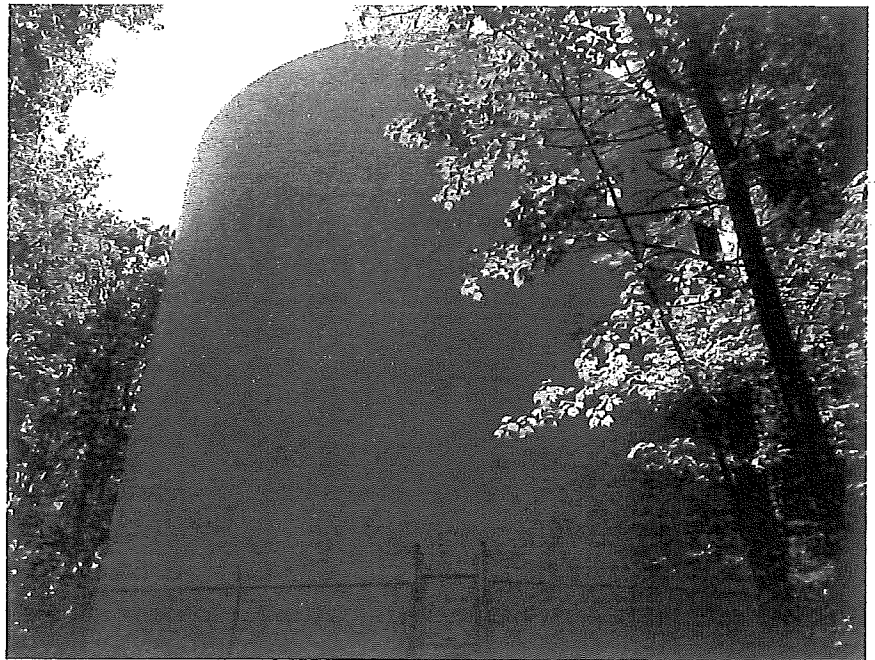
In August, 2016, Utility Service Group (USG) conducted an ROV Inspection on the Blue Spruce 2,000,000 gallon tank. The purpose of the inspection was to determine the condition of the coatings and structure, and to evaluate the tank for compliance with current sanitation guidelines, safety and security regulations, and guidelines in accordance with the AWWA, OSHA, and related state and federal agencies. The information contained herein is as accurate as could be obtained by USG personnel at the time of the inspection.

The subject tank is currently in very good structural and sanitary condition with no immediate remedial work from a structural standpoint on the tank itself. Missing grout and some spalling of concrete was noticed at the base of the tank which should be addressed.

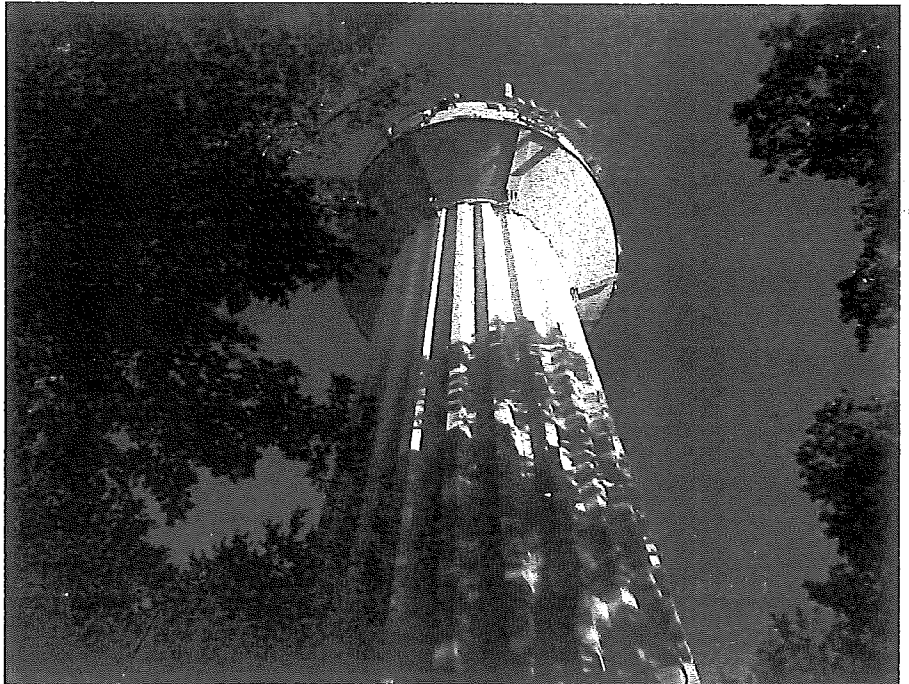
In August, 2016, Utility Service Group (USG) conducted an ROV Inspection on the Knolltop 300,000 gallon tank. The purpose of the inspection was to determine the condition of the coatings and structure, and to evaluate the tank for compliance with current sanitation guidelines, safety and security regulations, and guidelines in accordance with the AWWA, OSHA, and related state and federal agencies. The information contained herein is as accurate as could be obtained by USG personnel at the time of the inspection.

The subject tank is currently in very good structural and sanitary condition with no immediate remedial work from a structural standpoint.

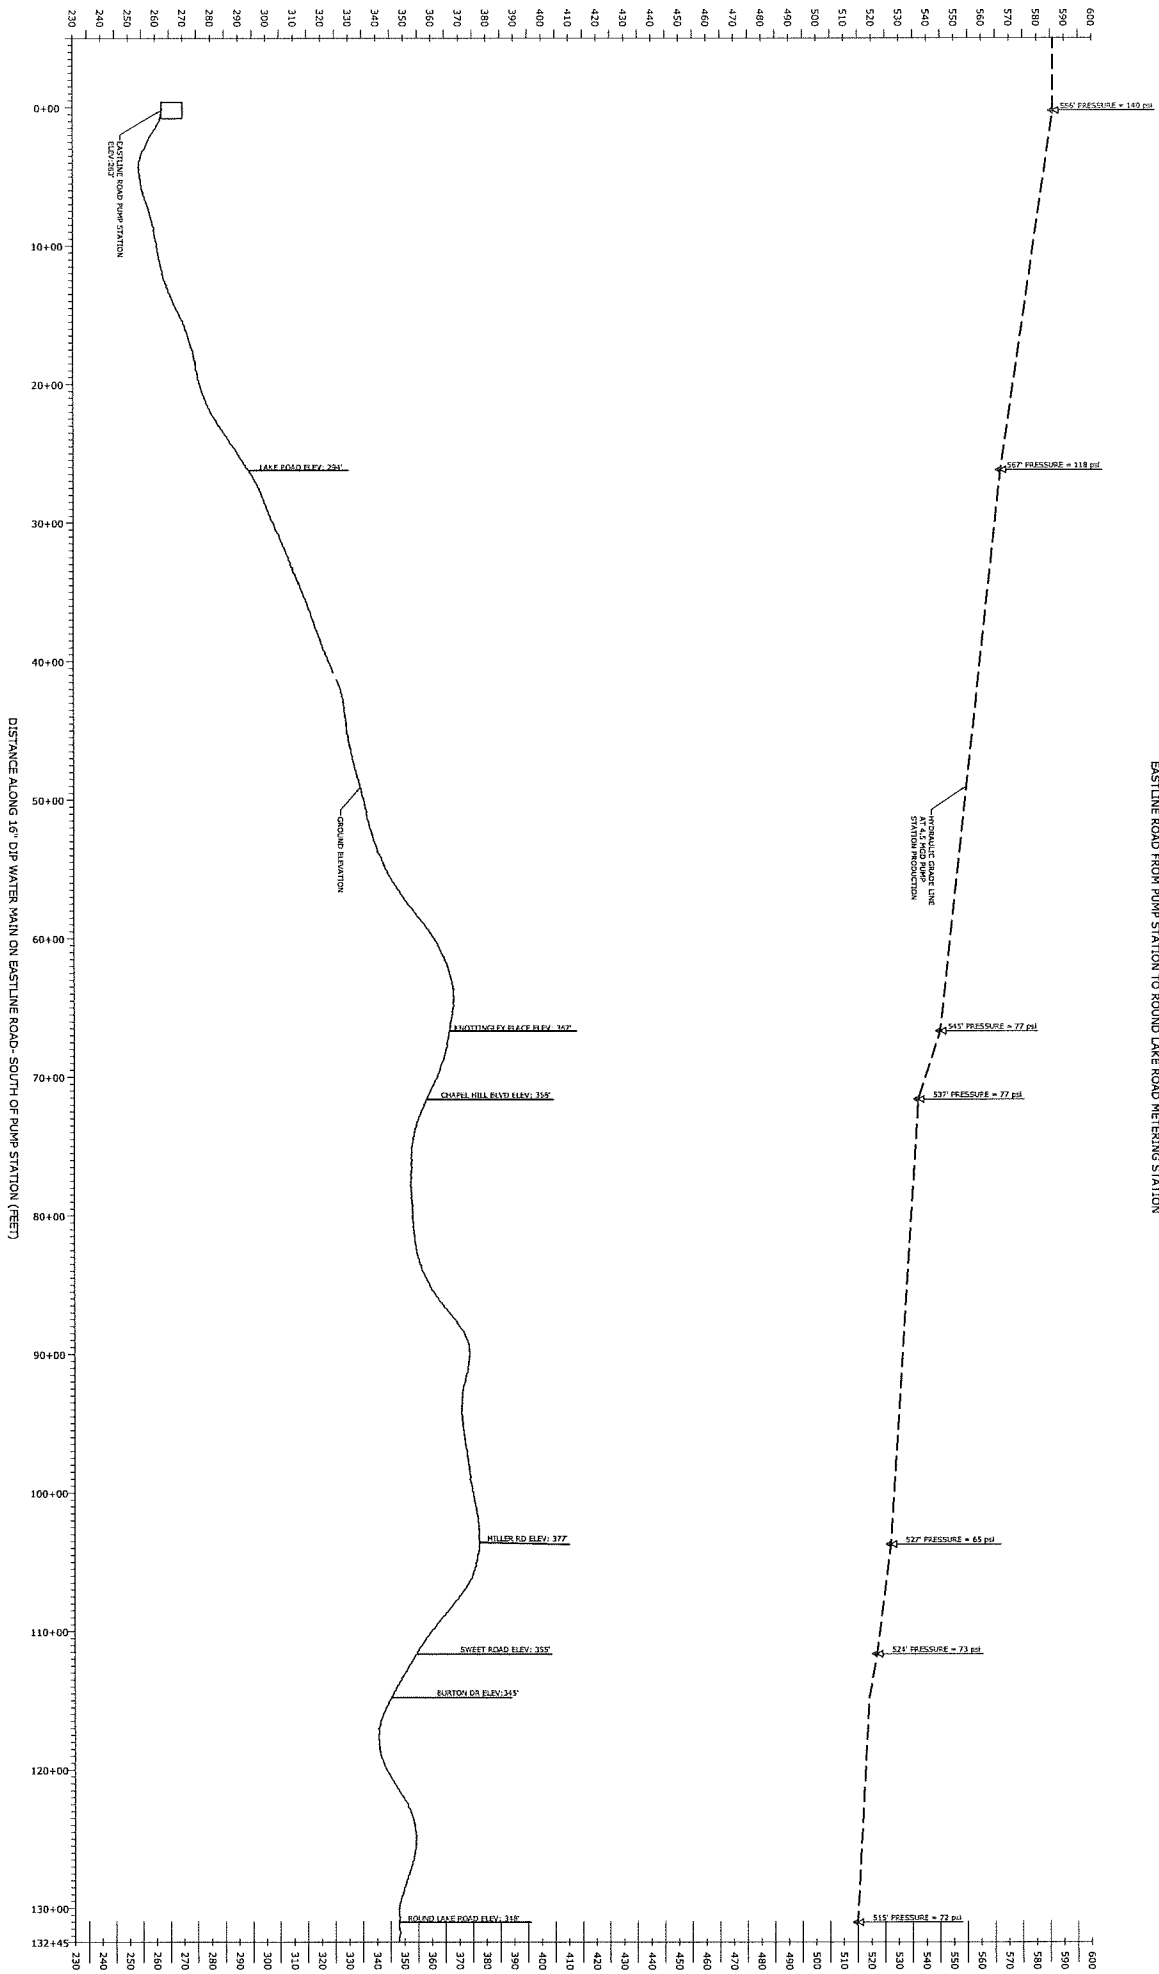
INCREASE SCWA INTERCONNECTION CAPACITY AT EASTLINE ROAD:
HYDRAULIC GRADE LINE & PRESSURE PROFILE - PROPOSED WITH EASTLINE ROAD PUMP STATION EXPANSION
EASTLINE ROAD FROM PUMP STATION TO ROUND LAKE ROAD METERING STATION
